Short-term Automated Monitoring of the Danube Bridge in Sinzing

The short-term use of an automated monitoring system to record the movements of the “Donaubrücke Sinzing” motorway bridge over the River Danube close to Regensburg in Germany is presented. It had recently been observed that excessive wear of the PTFE sliding discs of some bridge bearings had occurred, and it was surmised by the responsible engineers that this resulted primarily from the frequent movements of the bridge deck, which could be observed when traffic passed over the bridge. It was decided to install an automated monitoring system in order to assess the actual movements of the bridge, with particular attention to total additive sliding distance over a period of time. This information would then be used to verify the theory that excessive movements had been responsible for the wearing away of the PTFE, and to specify sliding materials for use in a refurbishment project. The short-term nature of the proposed project, combined with the standard types of measurement required, made a very elegant solution possible: a portable, stand-alone monitoring system was fitted with the required sensors, configured and inst

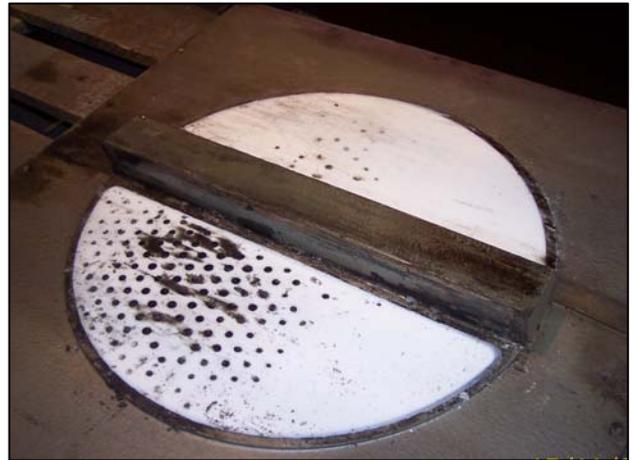
The bridge carries the German Autobahn No. 3 over the River Danube near the town of Sinzing (close to Regensburg), and is thus an important transport artery. It was observed by the bridge owner that the bridge moves significantly under normal traffic loading, and that the PTFE sliding material of a number of the bridge bearings had already been worn away to the point that it required replacement, as shown in Figure 2. This condition was reached after only five years of service, although PTFE sliding material can be expected to last at least twenty years under “normal” conditions. Therefore it was surmised that the unusually large movements of the bridge had resulted in the early wearing away of the PTFE.

Fig. 2 Damage to PTFE of bridge bearings

It had been observed during bridge inspections that the PTFE sliding material of a number of the bridge bearings had already suffered significant wear after only 5 years of service. However PTFE sliding material can normally be expected to last much longer. An attempt had already been made to solve this problem by replacing the sliding material with new PTFE discs, however the problem repeated itself within a few years.

It was also observed that the bridge moves significantly under normal traffic loading. Therefore it was surmised that the large movements of the bridge were responsible for the problem with the PTFE. A new sliding material, known as RoboSlide, a special high-grade polyethylene material which has been tested over a sliding distance of 60 km with no signs of abrasion, had newly become available, and it was anticipated that this would be a suitable sliding material, even giving the extreme movements of the bridge. However it could not be concluded that this change alone would result in a lasting solution. If the accumulated sliding distance of a bearing would significantly exceed 60 km over the life of the bearing, then an alternative solution such as the addition of dampers or strengthening members to reduce the bridge movements might also be considered. A monitoring system was proposed to gather information on the actual movements of the bridge and determine if the movements of the bridge were within the sliding distances that could be supported by the new sliding material. A similar solution has been concluded for a similar problem at the Ponte 25 de Abril in Lisbon [1].

It is known that PTFE sliding material is susceptible to deterioration already after 10,000m, and no further exceptional conditions were observed at the bridge which could explain such early deterioration of the sliding surface material. Therefore it was concluded that the excessive movements of the bridge were indeed the primary cause of the wearing away of the PTFE discs.

Based on the results from the monitoring project it was decided to replace the sliding discs of the bearings with the new RoboSlide material, which not only exhibits far higher resistance to wear than PTFE, but also offers lower friction values. It can thus now be expected that the new sliding discs will perform well for the remaining life of the bearings.

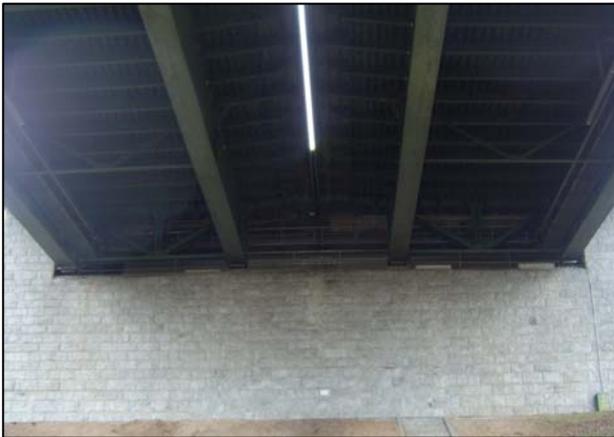
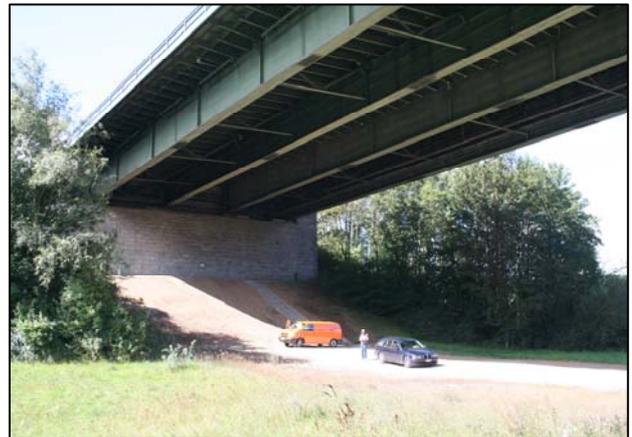
The steel bridge deck is composed of two separate constructions, one for each carriageway of the motorway. Each of these consists of two large steel girders which span the gaps between the the abutments and pillars, and smaller transverse members between the girders. This construction is shown in Figures 4 and 5, which present views of the West Abutment from below.

Fig. 4 & Fig. 5 Views of West Abutment
