Seismic retrofit of an existing fire station to ensure its critical emergency response function

Thomas Spuler
Mageba SA, Switzerland

ABSTRACT: Certain elements of a country's infrastructure, which are critical to the region's response to a catastrophic event, must continue to function in the aftermath of an earthquake. This applies not only to the roads and bridges which must continue to facilitate the movement of affected people and emergency services, but also to the buildings which will be vital to relief efforts. Hospitals must provide care to the injured at a time when the number requiring care suddenly multiplies; police stations must be centres of stability and order when chaos suddenly threatens; and fire stations must continue to fulfill their role in preventing the spread of any fires which will inevitably follow a serious seismic event, and in providing emergency search and rescue services. Very often such buildings, perhaps built many years ago, were not constructed to be earthquake proof, arising in the need for works to be carried out retrospectively in order to ensure a building's survival and usefulness following an earthquake. A project to make one such critical

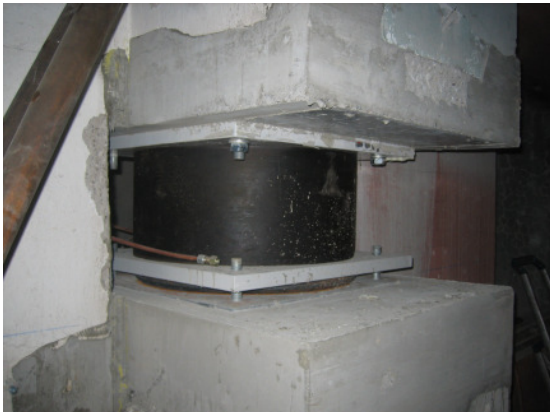
Figure 5. Seismic bearing installed beneath pillar at perimeter of building

Seismic bearings, which during an earthquake will control and determine the movement of the building relative to the supporting and surrounding soil, were placed beneath the building's main load-bearing elements (the columns at the perimeter of the building), as shown in Figure 5. These bearings primarily consist of cylindrical elastomeric blocks which are internally reinforced by a series of horizontal steel plates (as illustrated in Figure 6), and are equipped with external steel anchoring plates.

The bearings allow very little vertical deformation, which is important for the building above, but can through shear deformation of their elastomeric layers facilitate significant horizontal movements. This elastic deformation, much "softer" than the sudden jerking movement which would result in the absence of these bearings, is key to the effectiveness of this type of bearing in a seismic situation. The performance properties of the bearings can be modified by adapting their physical dimensions and chemical and mechanical properties (such as shear modulus and damping), with their hysteresis and damping behaviour designed to suit the calculated requirements of the structure during a seismic event.

To avoid differential settlements of one part of the building relative to an adjacent section during sequential installation of the seismic bearings, which could arise due to the 2.5 mm compression to be expected in each bearing, a flat hydraulic jack was inserted beneath each seismic bearing, and used to pre-compress the bearings to 95% of the stress which would apply under permanent loading. These flat jacks, which can also be seen beneath the bearing in Figure 5, were injected with quick-hardening cement grout to achieve and maintain the appropriate height, and permanently left in the structure.

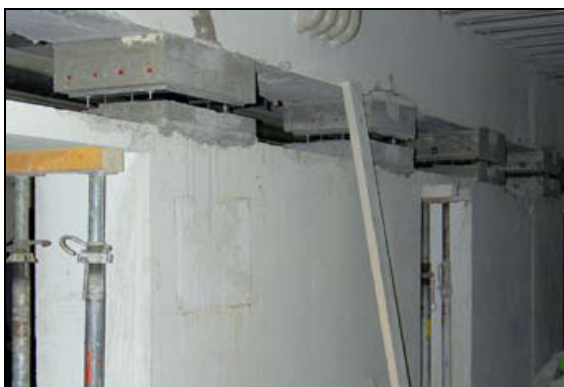
Figure 7. Sliding bearings inserted in internal basement wall

The sliding bearings were introduced beneath the open central area of the ground floor, which has no walls or pillars above, and thus serve to transfer the weight of the floor slab and vehicles to the longitudinal walls beneath while allowing the floor slab to move as determined by the seismic bearings at the perimeter. The installation of a row of sliding bearings in one internal basement wall is shown in Figure 7. The bearings allow sliding movement in all horizontal directions, resisting only downward forces. Each bearing consists of a reinforced elastomeric bearing, similar to that shown (with corner cut out) in Figure 8, with a PTFE sliding surface on the upper surface, positioned between two steel anchoring plates, one of which has a stainless steel sheet welded to its lower surface as a sliding partner for the block's PTFE surface.

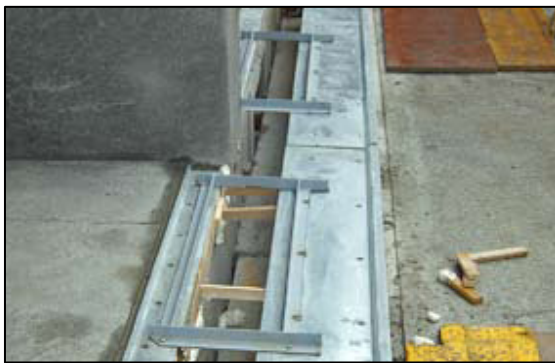
Figure 9. Installation of expansion joint

In order to enable the building to move relative to its basement walls on the bearings described above, the backfill to the basement walls had to be removed down to the level of the newly installed bearings. Any soil against the wall above this level would resist the building's movement, negating the effect of the introduced bearings. This required the construction of subsurface walls to maintain the shape of these new recesses (as shown in Figure 4). The gap at the top of each recess will vary during an earthquake as the building moves relative to the adjacent paving, but it was not possible to leave this gap open, as fire brigade vehicles need to cross the gaps in entering and leaving the building every day. Therefore sliding plate expansion joints were installed at ground level along both long sides of the building, as shown in Figures 9 to 11.

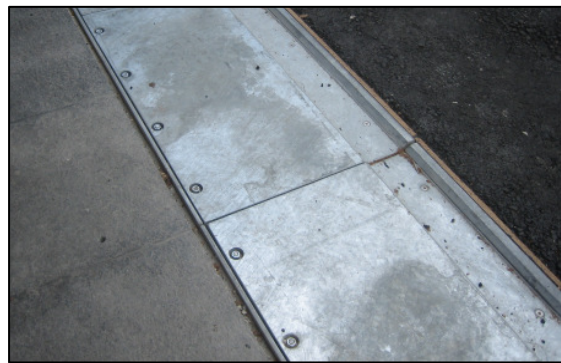
Figure 10. Installed expansion joint at vehicle exit

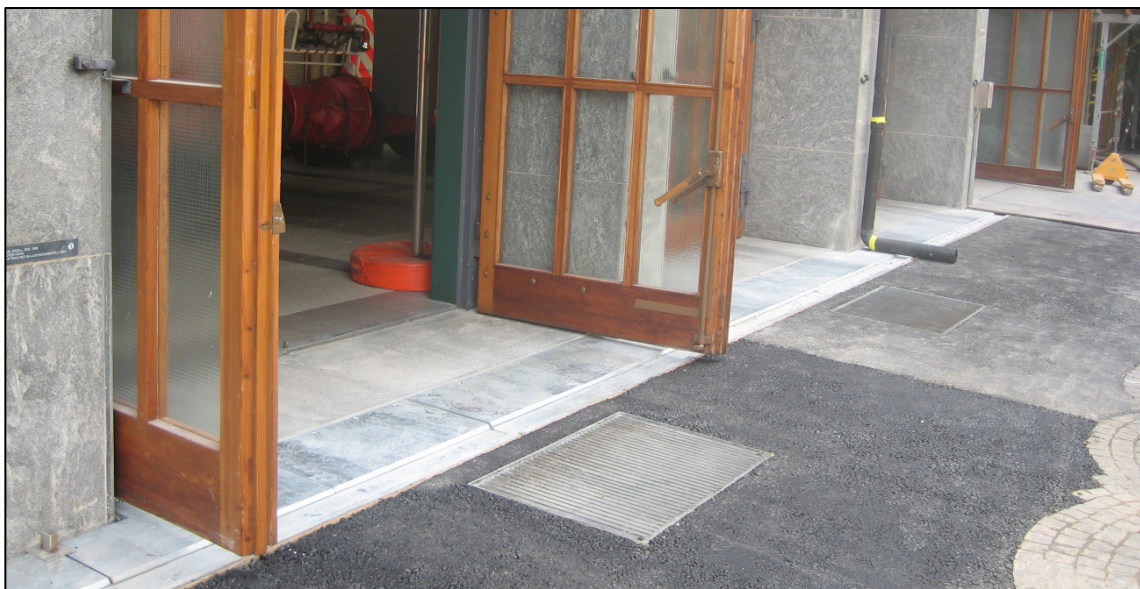
Figure 11. Vehicle exit point after completion of works, showing new stainless steel expansion joint
